Re: Mark Raabe, Thai 66; Engineering Projects in Yasothon Province

The following are a series of photographs related to engineering projects in Yasothon Province during my tenure as a Peace Corps from Oct. 1979 to Oct. 1981. I participated in the design of these projects. The projects were constructed in 1982, after my COS.

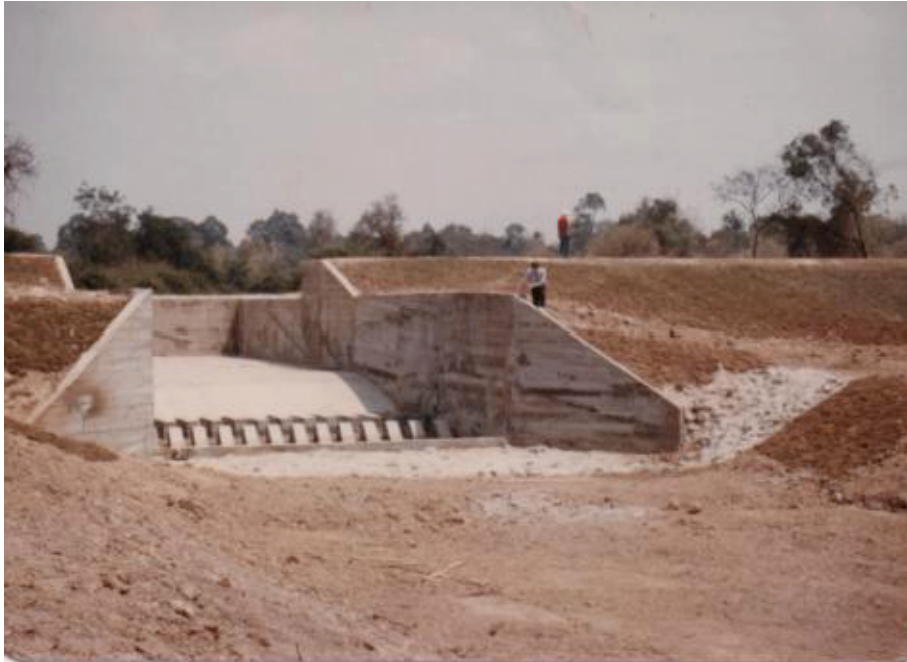
Photo #1: Box inlet spillway on a small tributary within the floodplain of the Moon River.

The dam consisted of an earthen embankment approximately 100 meters long. The design of the spillway is a drop-inlet chute with stilling basin. An irrigation canal was constructed adjacent to the reservoir and located outside the floodplain. The irrigation system consists of a pump house, reinforced concrete inlet and concrete-lined channel.

The design of the dam and spillway addressed three conditions: 1) discharge from the reservoir to the creek below during the early stage of the rainy season; 2) the swelling of the Moon River during the latter stage of the rainy season, resulting in water flowing upstream and into the reservoir and final flood stages higher than the top of the dam; and 3) draining of the flood stage of the Moon River through the spillway.

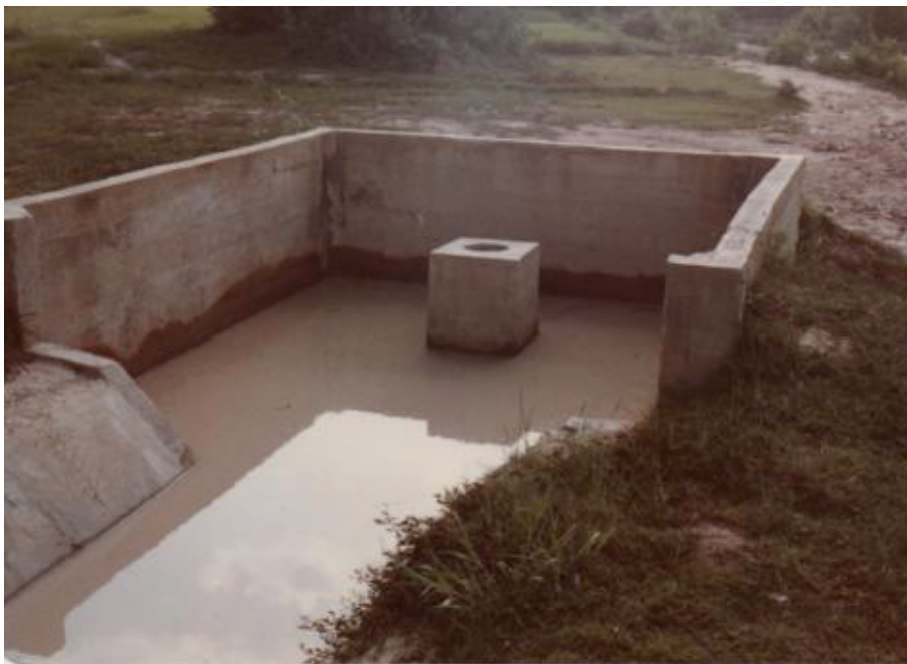
Photo #2: Inlet stilling basin for irrigation system.

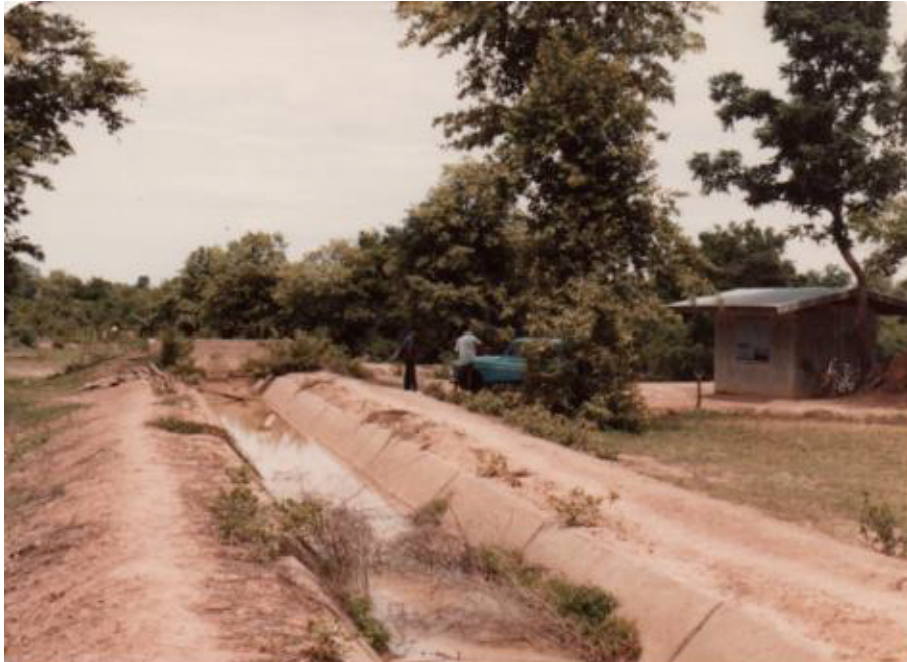
Photo #3: Head end of concrete-lined irrigation channel. The inlet stilling basin is in the background and the pump house is to the right.

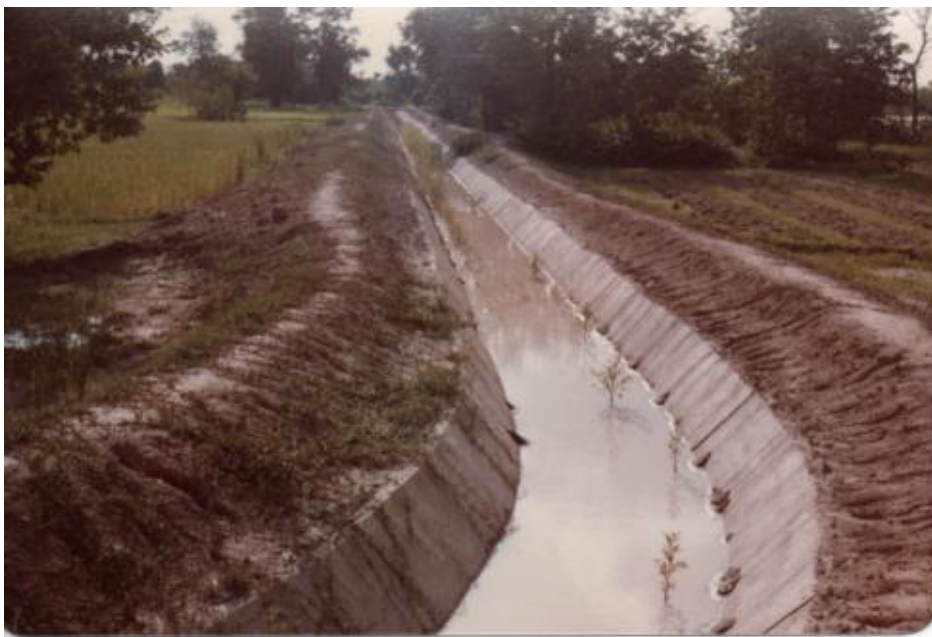
Photo #4: Section of the concrete-lined irrigation channel.

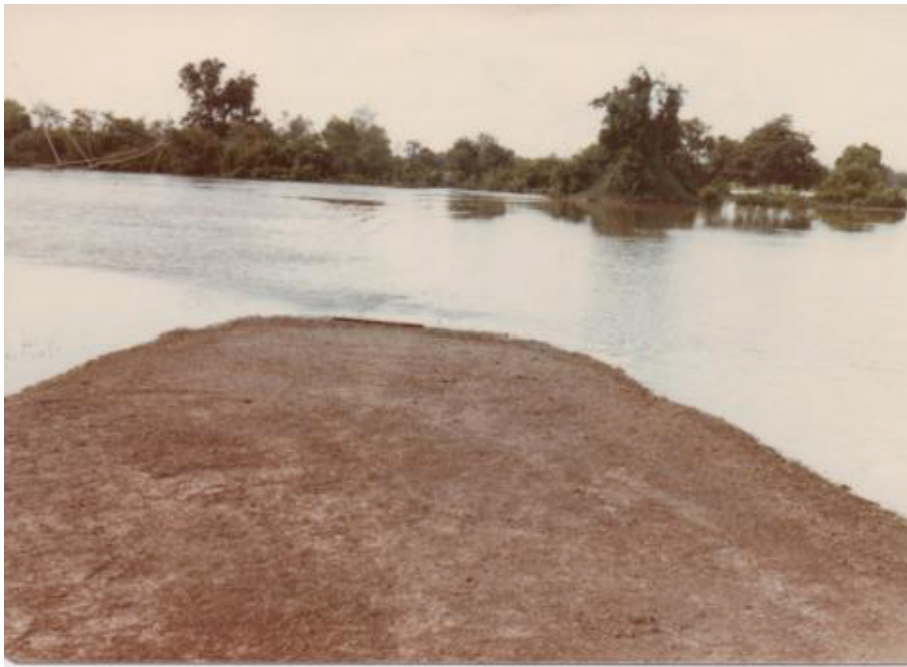
Photo #5: Spillway and dam are completely submerged, due to flooding of the Moon River.

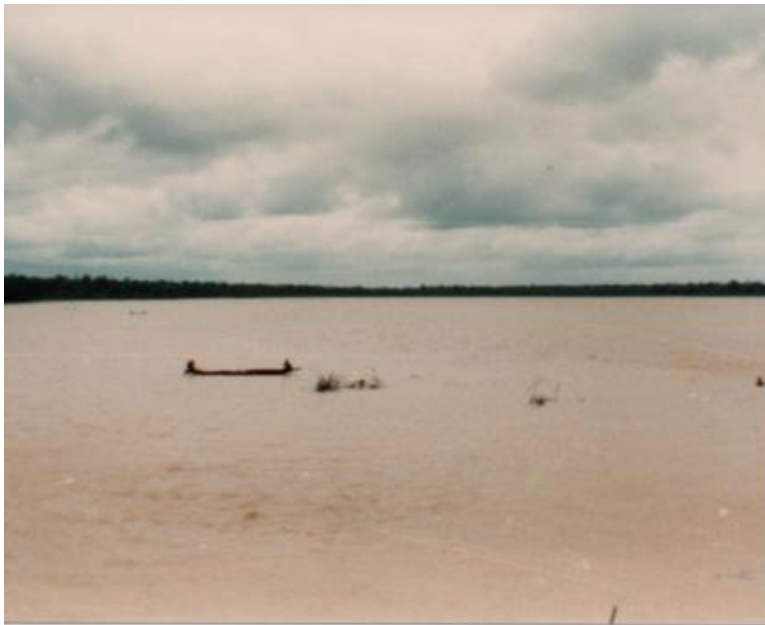
Photo #1: The elevation of this lake was to be increased through the construction of a dam. A dam was previously constructed by local villagers but without a concrete spillway. The previous dam was subsequently destroyed during an ensuing flood event.

Overview of Project #2: The villagers adjacent to a natural lake (name no longer remembered) requested the government to construct a dam to raise the lake level and provide a year-round road connecting either side of the lake. Historically, a dam was constructed by the local villagers but was subsequently destroyed by flooding. [Note: The previous dam did not include a spillway.]

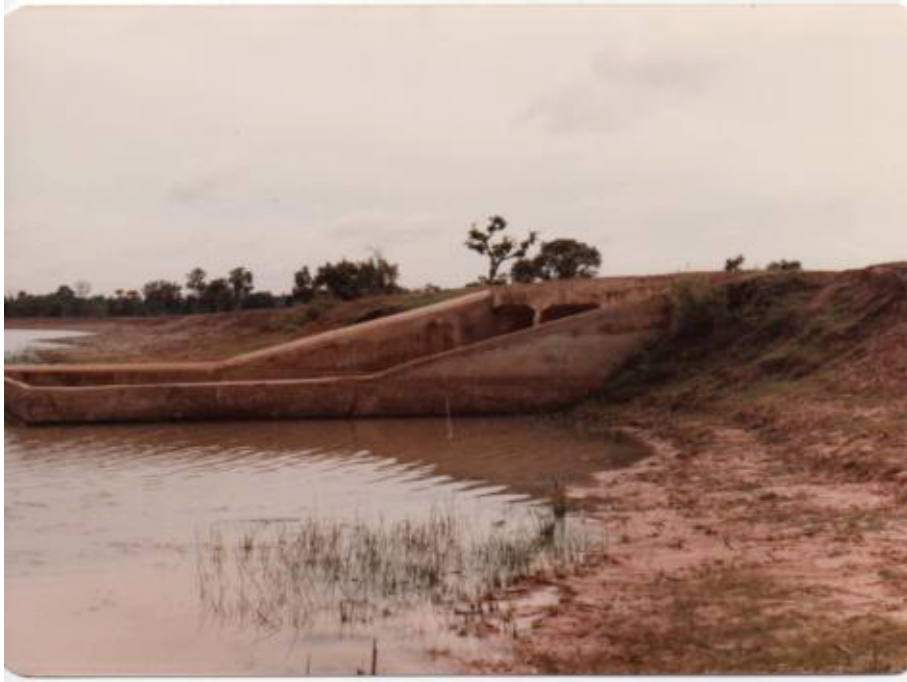
Photo #2: Box inlet drop spillway prevents erosion of the earthen embankment during flood events.

The project consisted of an earthen embankment approximately 1.5 km long capped with a roadbed consisting of laterite. The spillway consisted of a box inlet drop spillway. The design of the bridge spanning the spillway consisted of reinforced concrete with two support piers.

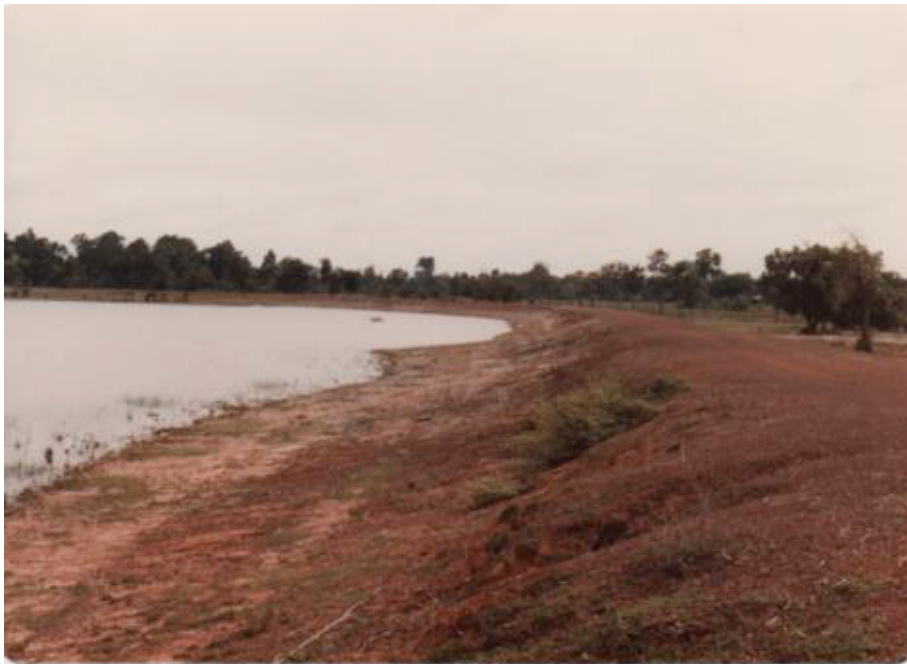
Photo 3: Laterite roadbed atop the earthen embankment. The earthen embankment remained structurally sound despite erosion from water buffalo at the toe, and lack of maintenance of the roadbed.

The project was completed in 1982. I visited the site with my former co-worker during the dry season in 1985. He indicated that the dam had never been breached.

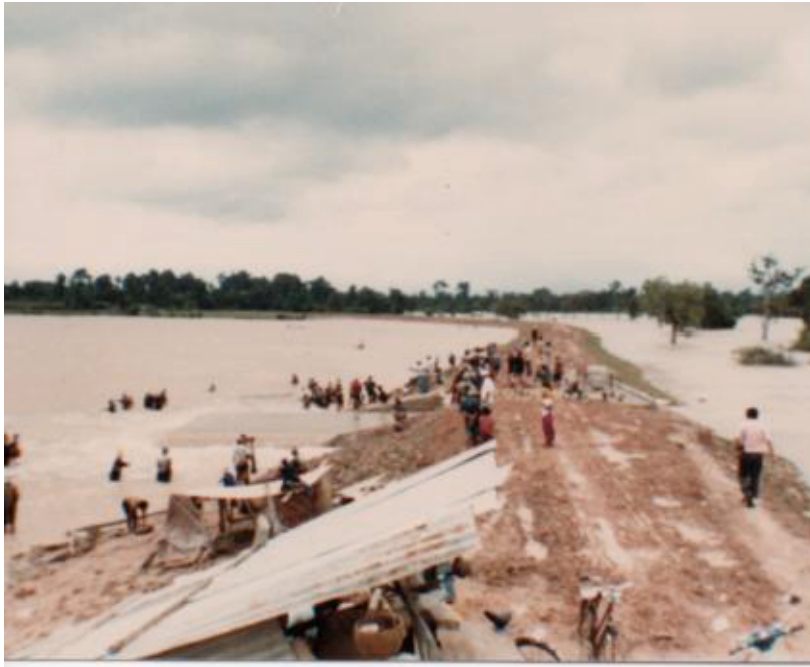
Photo #4: Water is flowing upstream into the reservoir (on left), due to flooding of the Moon River. Note: Villagers are gathered around the box inlet with nets to catch fish.

The design of the dam and spillway addressed two operating conditions: 1) discharge from the new reservoir to the creek below, resulting from accumulation of water within the drainage area of the

reservoir; and 2) flood stage of the Moon River during the latter stage of the rainy season, resulting in water flowing upstream and into the new reservoir.
